February 7, 2007

Re: Water Leak Test of 6<sup>th</sup> Floor Slender-Wall Panel (Panel #SWP 15/28)  
Virginia Beach Town Center – Westin Hotel Tower  
Virginia Beach, Virginia  
CTI Project No.: 00G-100

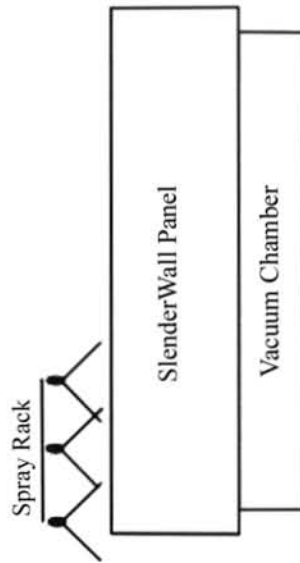
Spray Rack Positioned at Bottom Third of the Panel Test Area

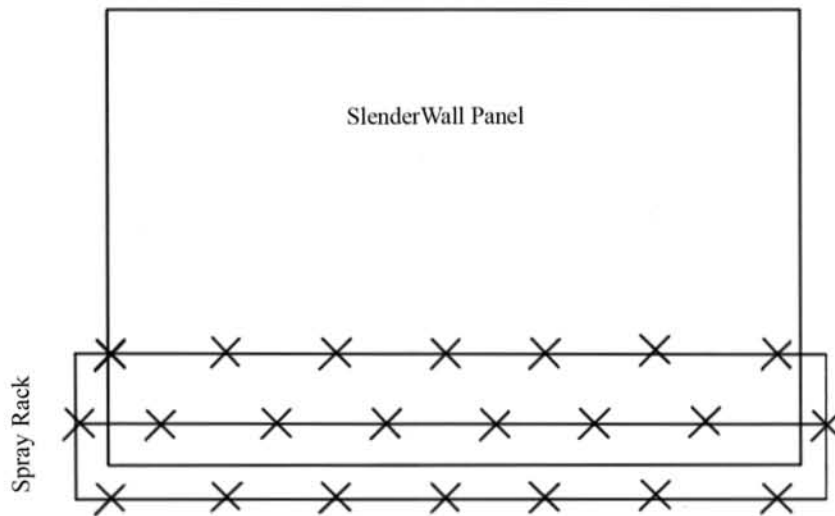
Sketch #1

Spray Rack Positioned at Bottom Third of the Panel Test Area
